# Manhole Inspection Summary

Manhole # S13OO1004MH

**Location** Address: **2800 ROSALIND AVE**

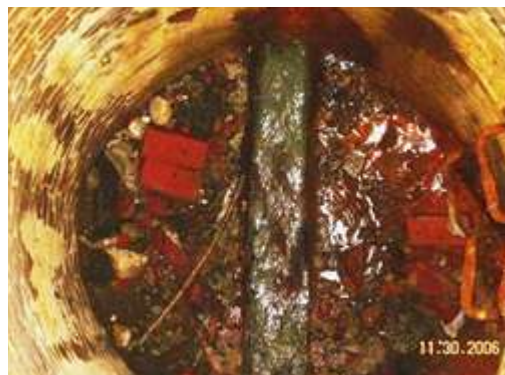
Top View

Corroded steps. Evidence of surcharge - Bench debris.

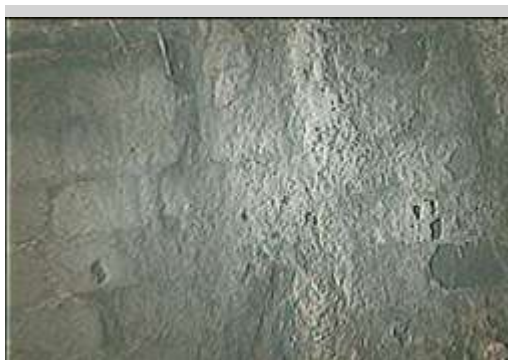
Defect

Barrel deterioration and infiltration.

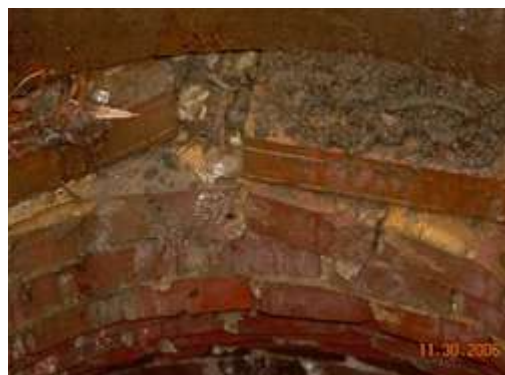
Defect

Frame leaks. Frame offset. Adjustment deterioration, loose brick and infiltration.

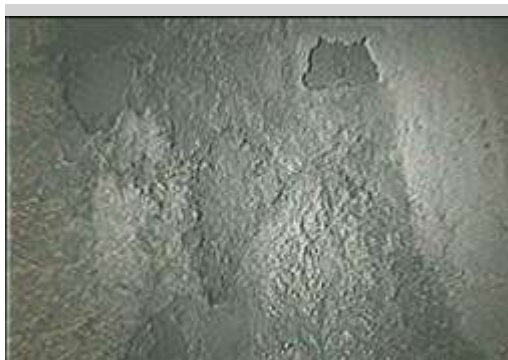
Defect

Barrel deterioration and infiltration.

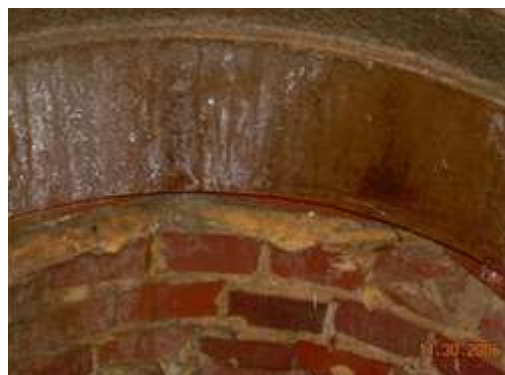
Defect

Frame leaks. Adjustment infiltration.

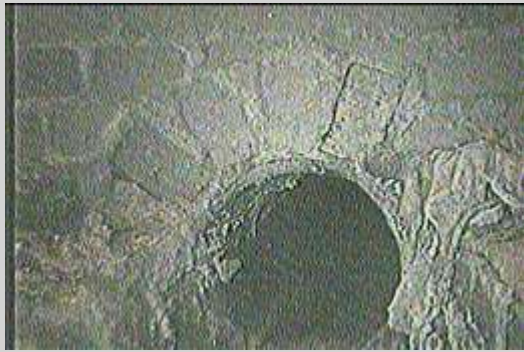
Pipe In @ 6 O'Clock

Deposits: ☐ None ☒ **Mud** ☐ Sludge ☒ **Debris** ☒ **Grease**

Infiltration: **Evidence** Pipe Seal Cond: **Unknown**
